APPENDIX D-3
AQUATIC RESOURCES DELINEATION REPORT

±920-Acre Eliot Facility Study Area

Aquatic Resources Delineation Report

March 2020 | CXC-01

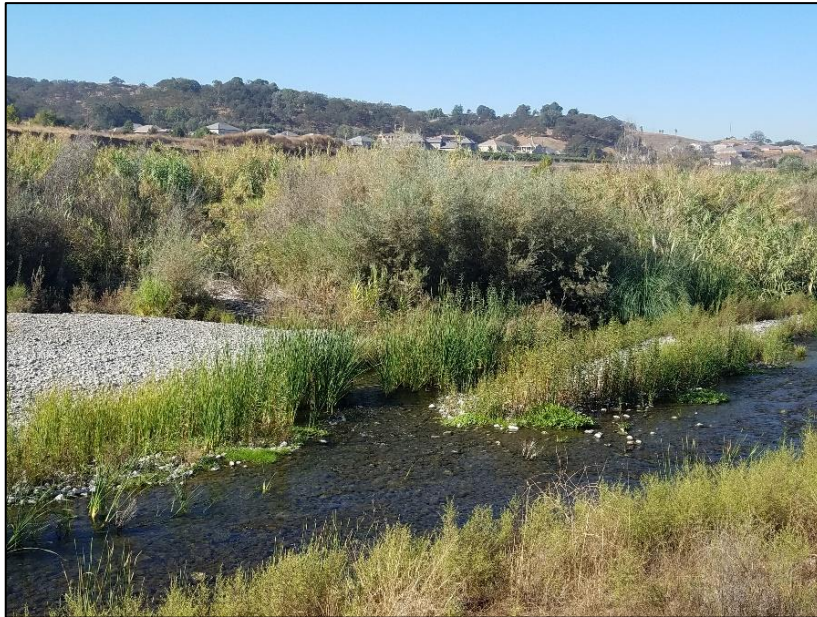
Photo Point 1. Looking northwest along the gravel bar within the OHWM of the perennial stream (Arroyo del Valle) in the central portion of the Study Area, during the October 26, 2017 biological survey.

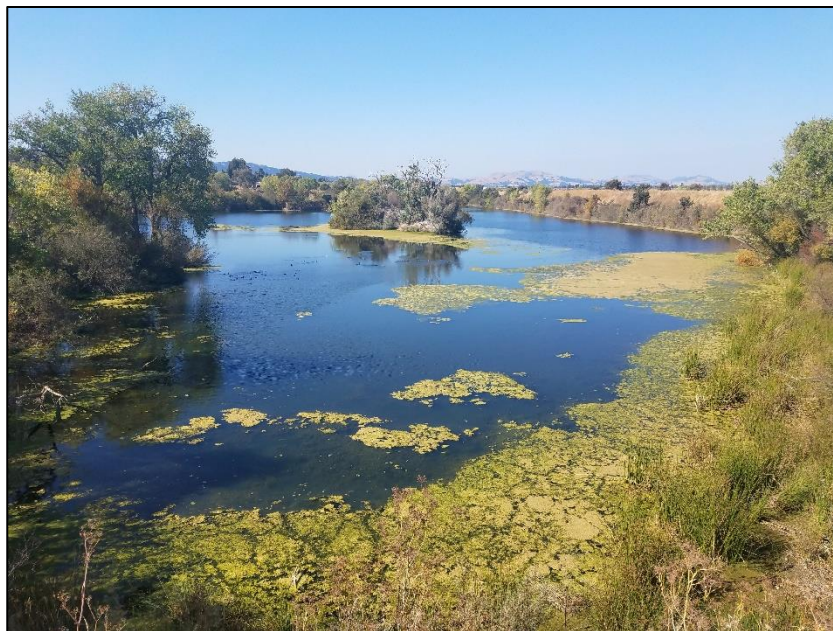
Photo Point 2. Looking northwest across the perennial pond located within the northwest portion of the Study Area, during the November 1, 2017 biological survey.

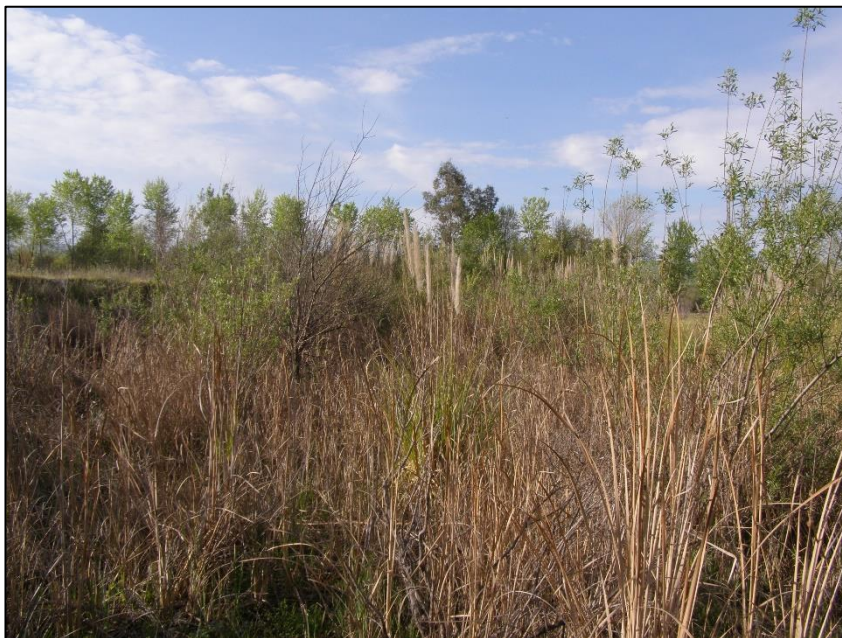
Photo Point 3. Marsh habitat within the southeastern portion of the Study Area, during the April 3, 2018 delineation survey.

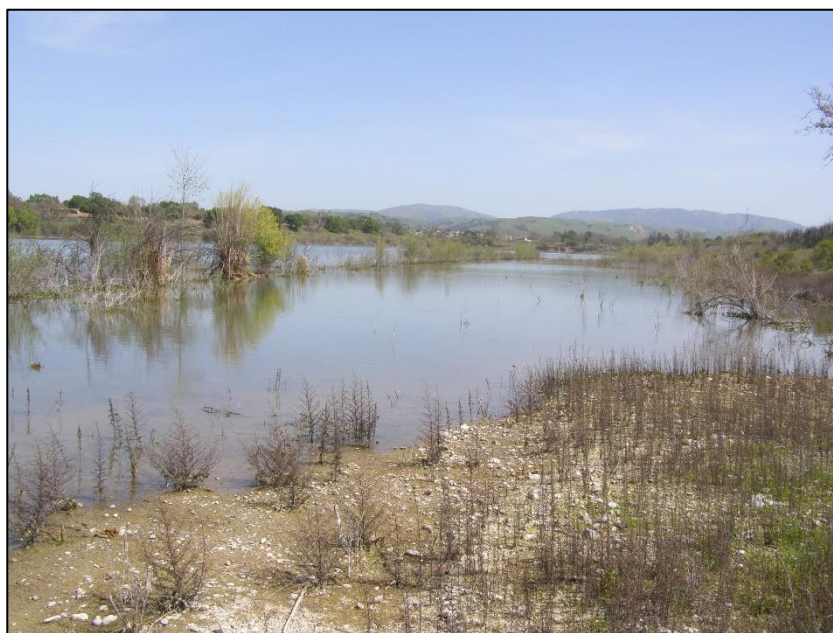
Photo Point 4. Looking east along Quarry Pond A in the southeastern portion of the Study Area, during the April 4, 2018 delineation survey.

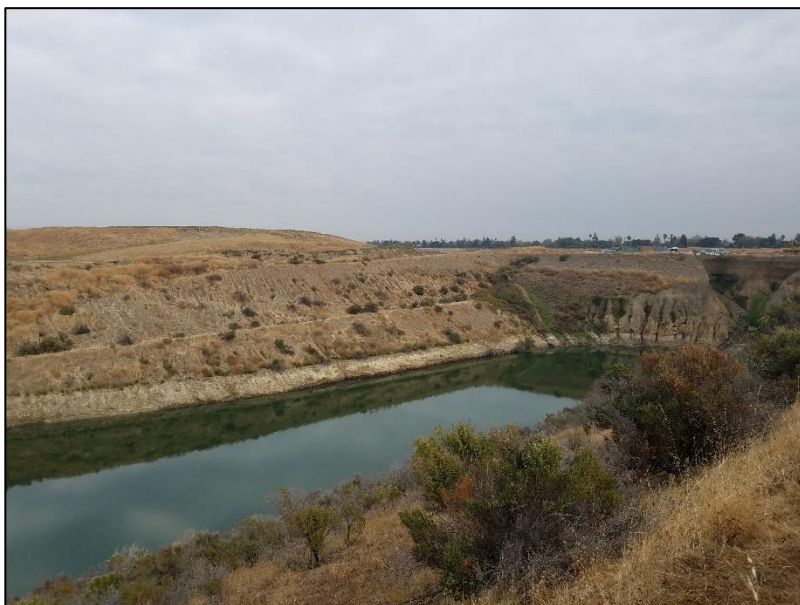
Photo Point 5. Looking east along Quarry Pond C within the northeastern portion of the Study Area, during the November 2, 2017 biological survey.

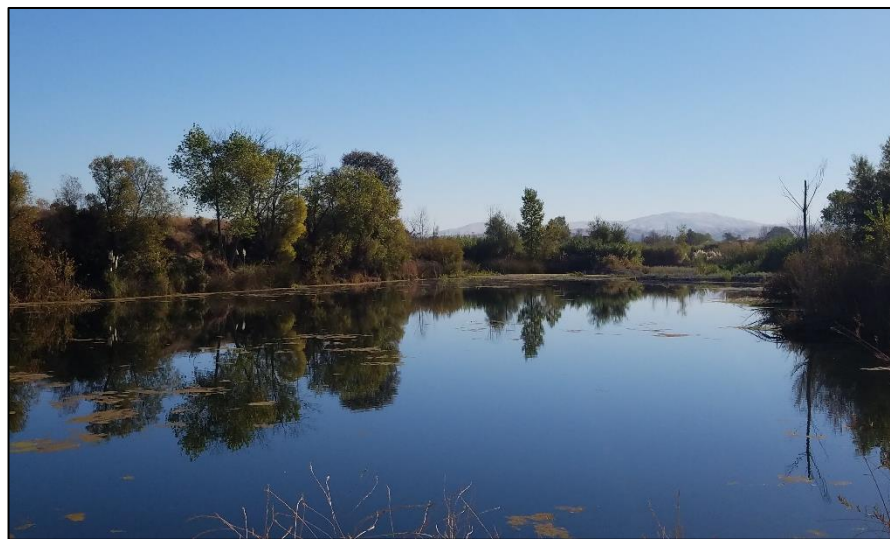
Photo Point 6. Looking east along one of the breached quarry ponds in the central portion of the Study Area, during the October 26, 2017 biological survey.

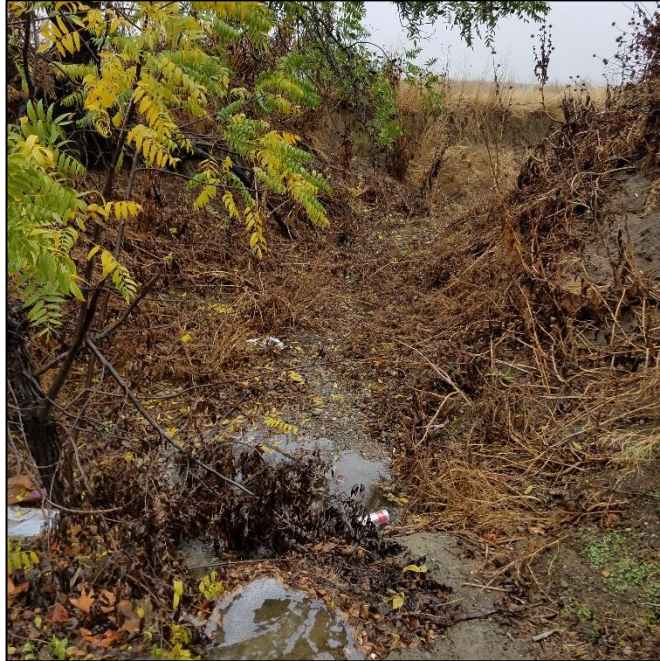
Photo Point 7. Looking north along the ephemeral drainage in the central portion of the Study Area, during the November 16, 2017 delineation survey.

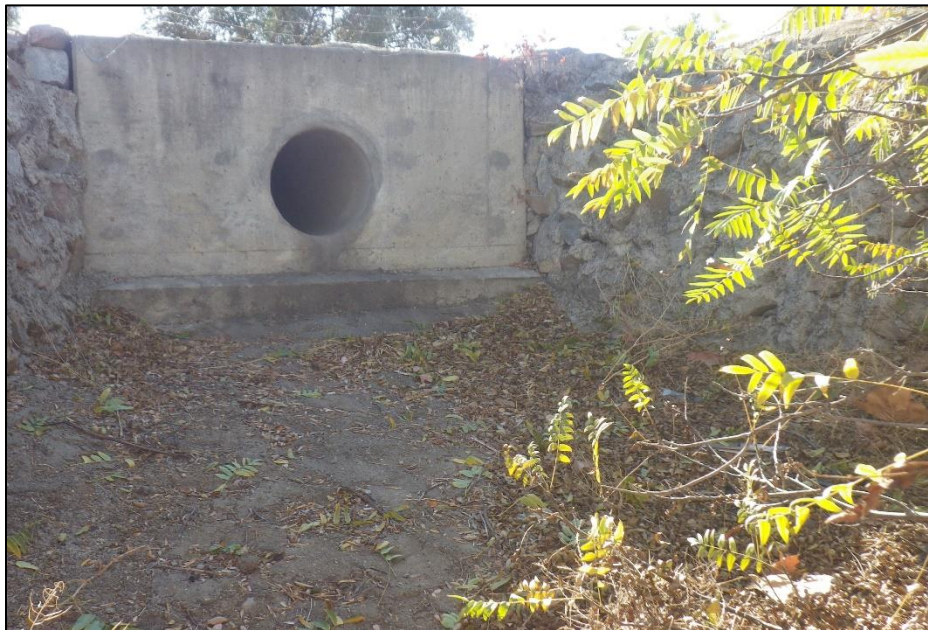
Photo Point 8. Looking south at the culvert that feeds the ephemeral drainage mapped during the November 25, 2019 delineation survey.

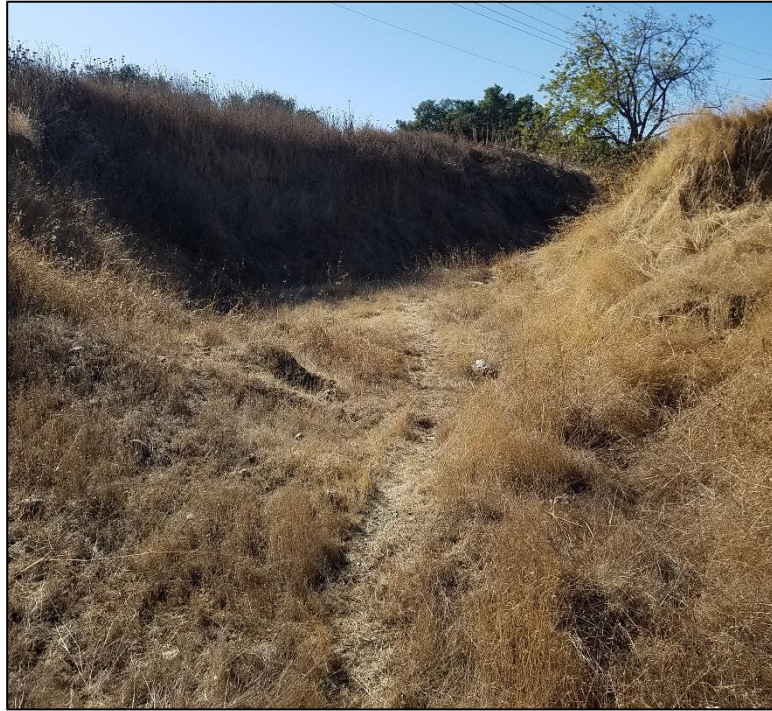
Photo Point 9. Looking southwest along the ephemeral drainage in the southern portion of the Study Area, during the November 25, 2019 delineation survey.

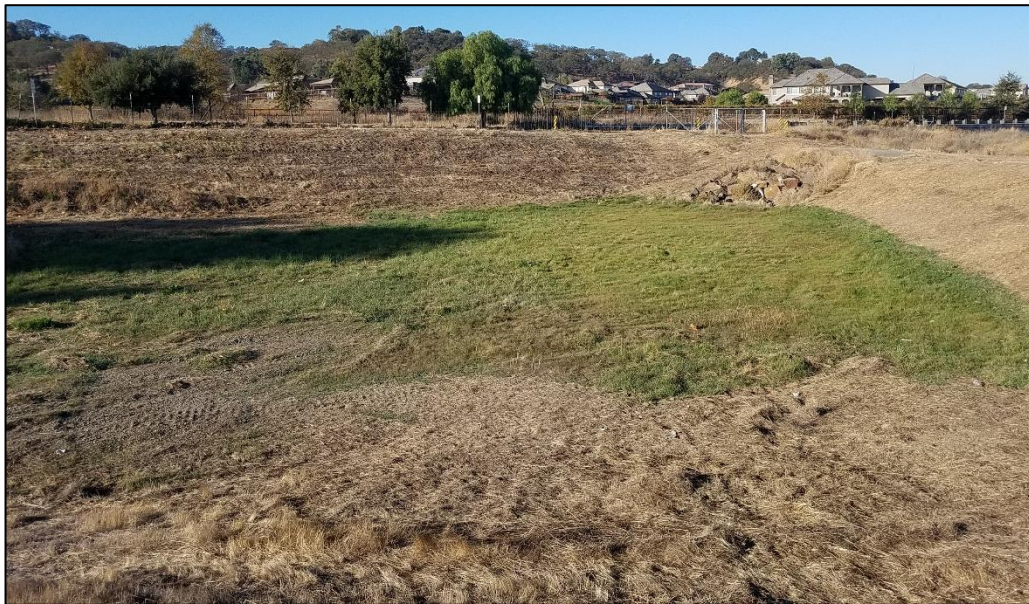
Photo Point 10. Looking southwest at the upper excavated basin in the southern portion of the Study Area, during the November 25, 2019 delineation survey.

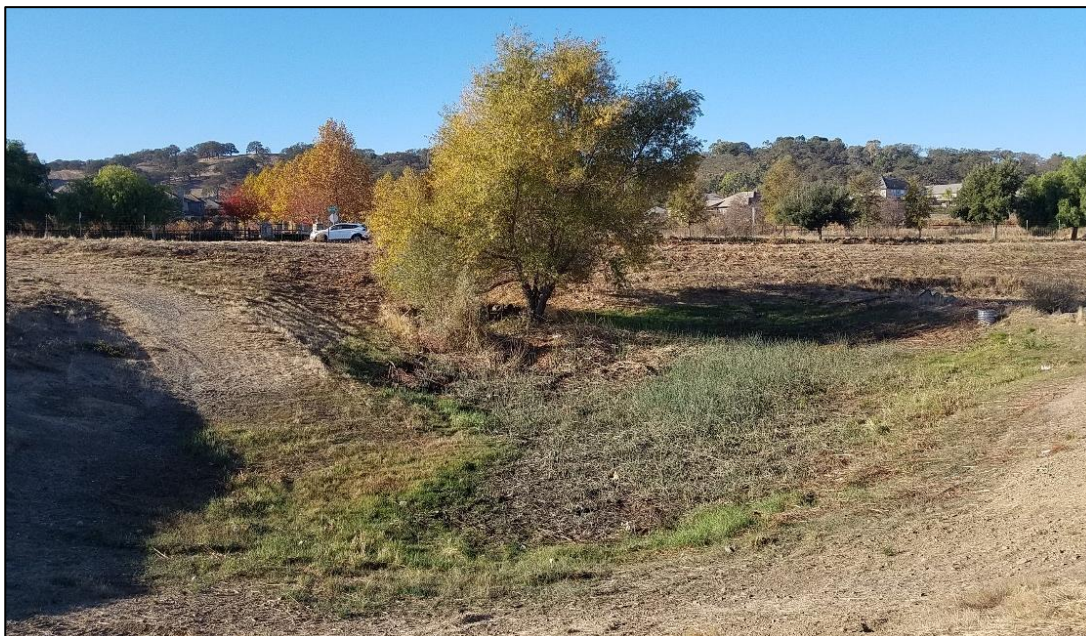
Photo Point 11. Looking south at the lower excavated depressional basin in the southern portion of the Study Area, during the November 25, 2019 delineation survey.

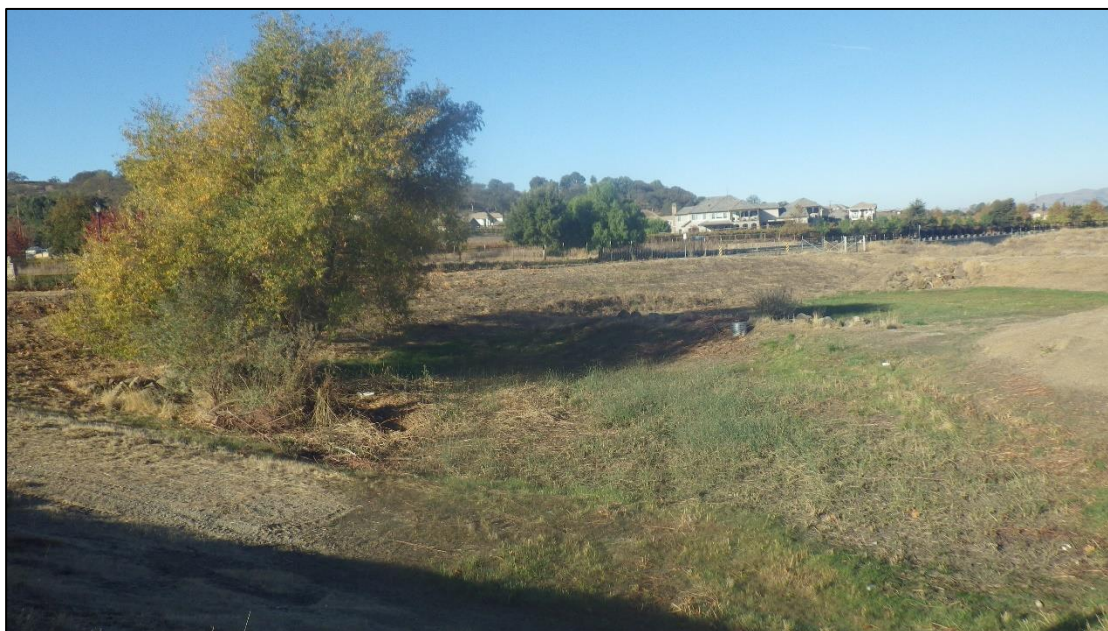
Photo Point 12. Looking south at both excavated basins in the southern portion of the Study Area, during the November 25, 2019 delineation survey.

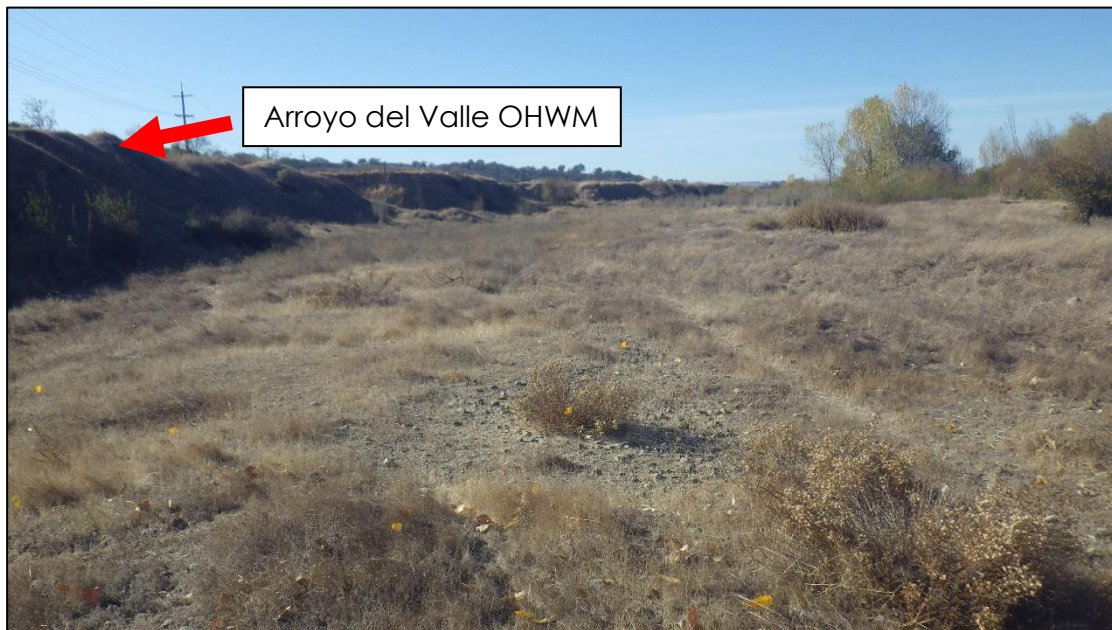
Photo Point 13. Looking west across the floodplain within the OHWM of the perennial stream (Arroyo del Valle) in the southern portion of the Study Area, during the November 25, 2019 delineation survey.

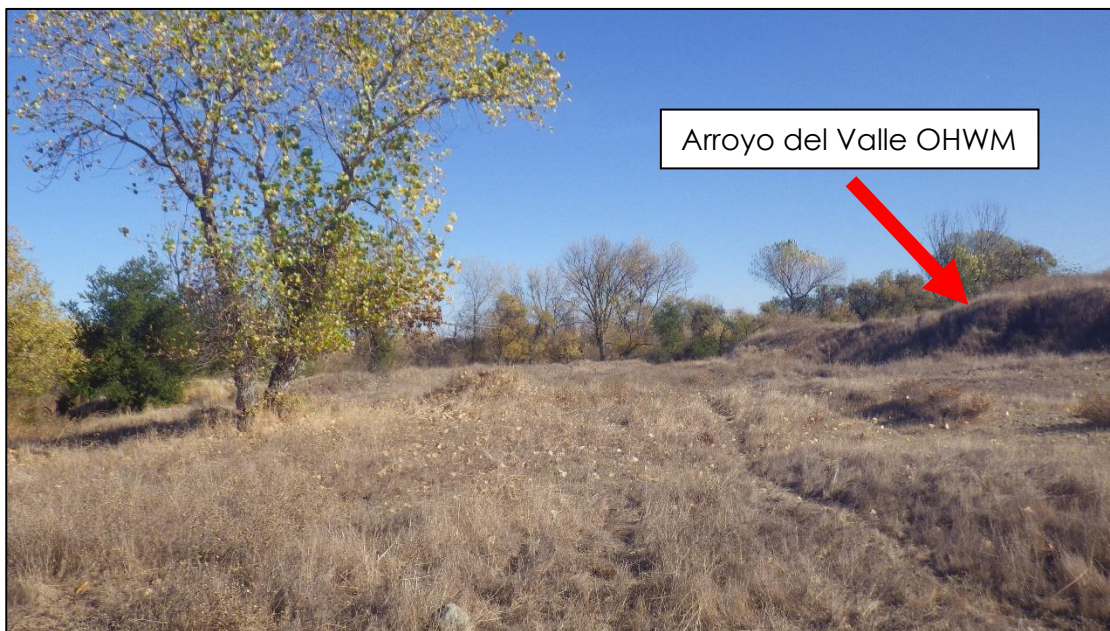
Photo Point 14. Looking east across the floodplain within the OHWM of the perennial stream (Arroyo del Valle) in the southern portion of the Study Area, during the November 25, 2019 delineation survey.

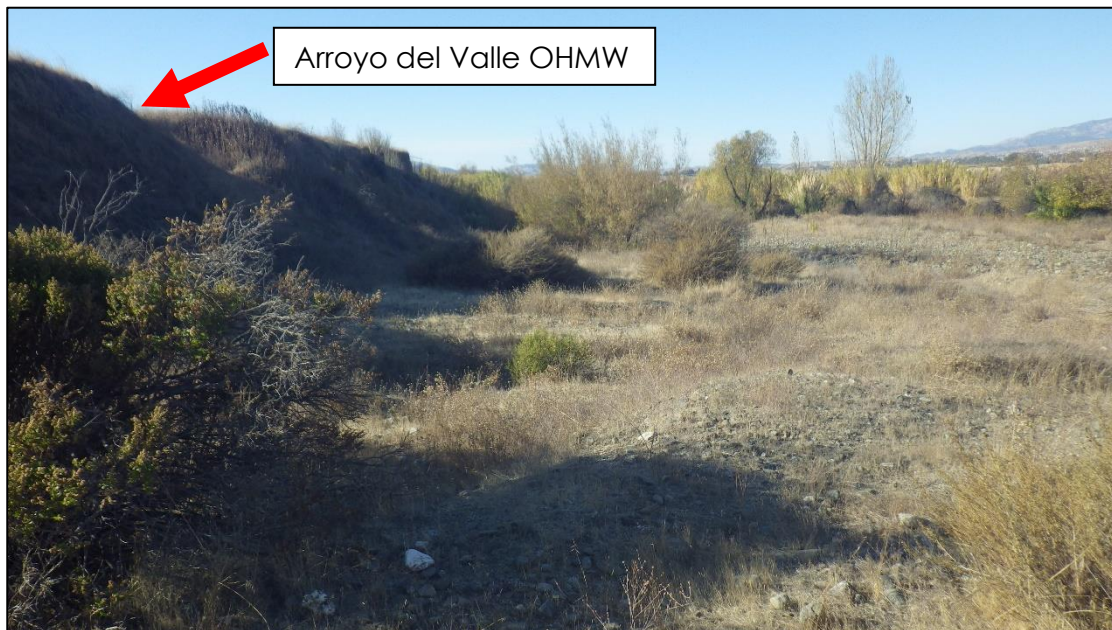
Photo Point 15. Looking northwest across the floodplain within the OHWM of the perennial stream (Arroyo del Valle) in the southern portion of the Study Area, during the November 25, 2019 delineation survey.

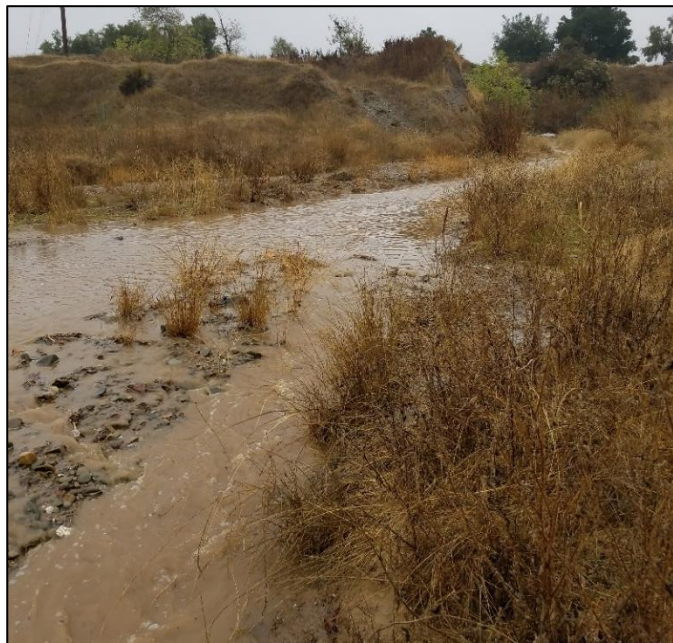
Photo Point 16. Looking west across the floodplain with OHWM of the perennial stream (Arroyo del Valle) within the southern portion of the Study Area, during the November 15, 2017 delineation survey.

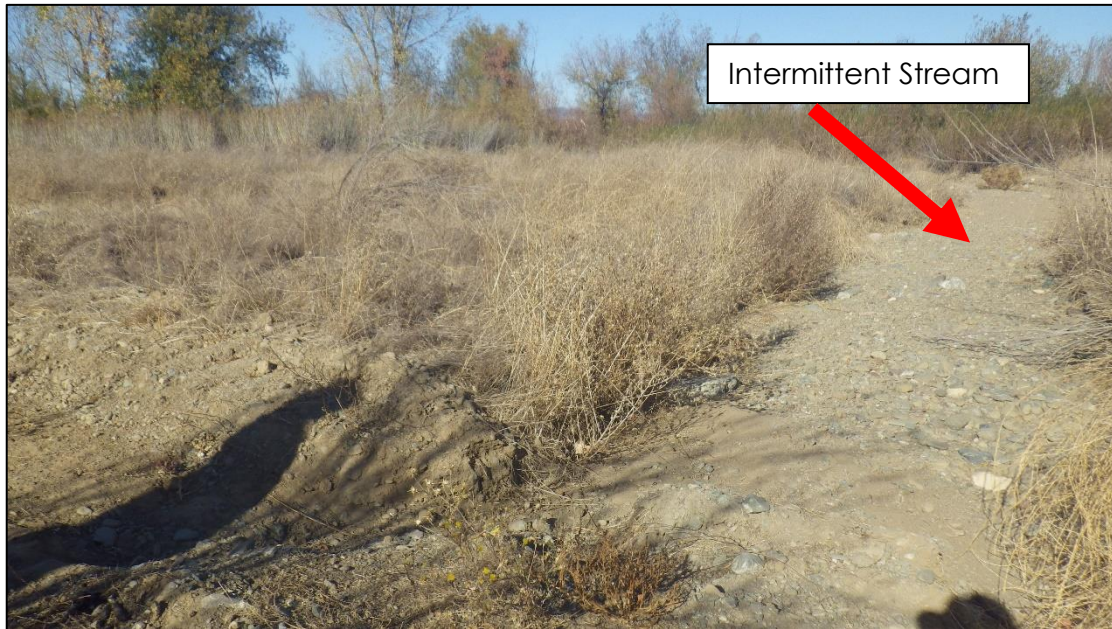
Photo Point 17. Looking west across an intermittent stream in the southern portion of the Study Area, during the November 25, 2019 delineation survey.

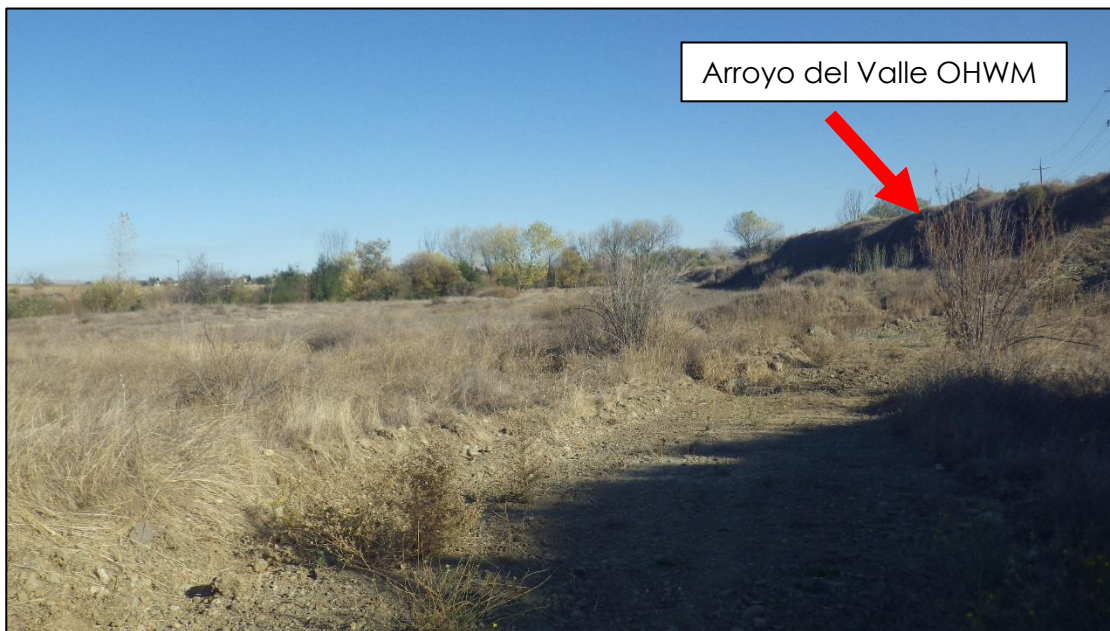
Photo Point 18. Looking west across the floodplain within the OHWM of the perennial stream (Arroyo del Valle) in the southern portion of the Study Area, during the November 25, 2019 delineation survey.

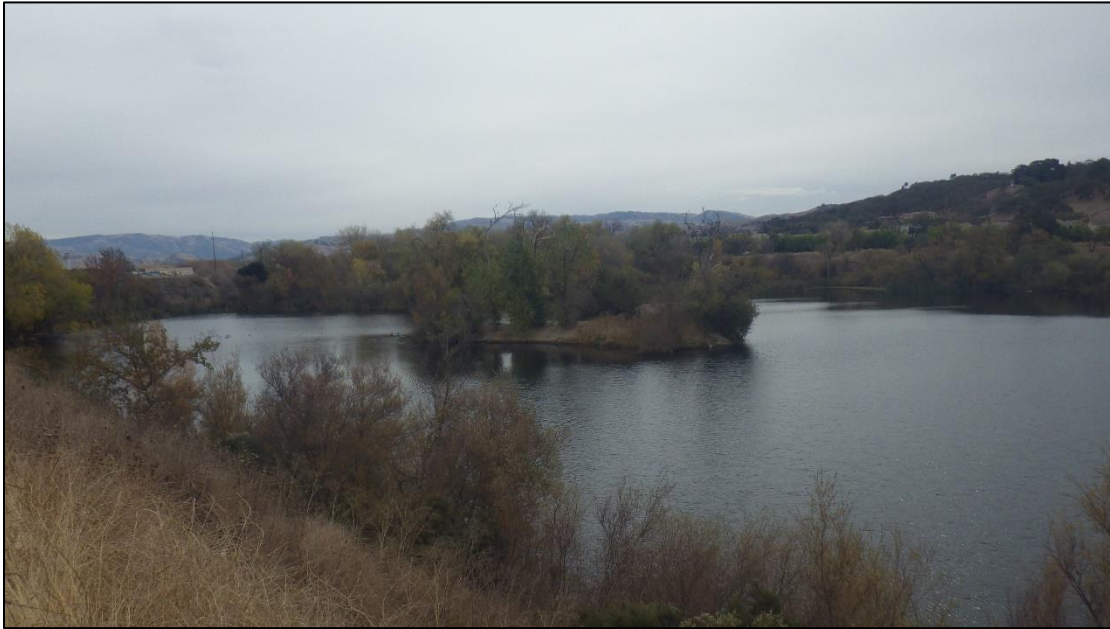
Photo Point 19. Looking south across the perennial pond in the northeastern portion of the Study Area, during the November 26, 2019 delineation survey.

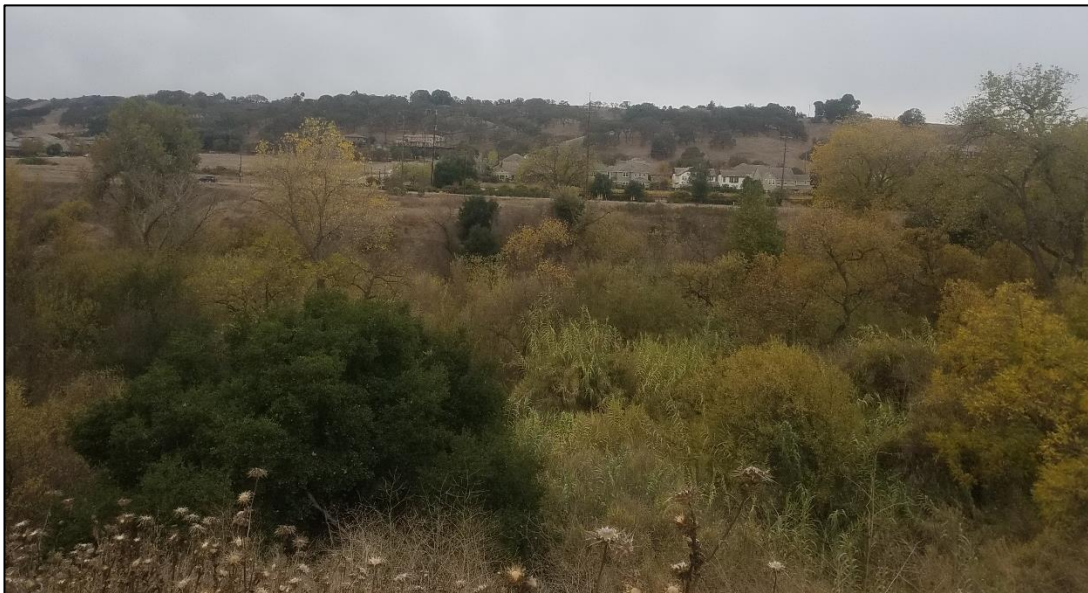
Photo Point 20. Looking south across the perennial stream (Arroyo del Valle) in the northern portion of the Study Area, during the November 26, 2019 delineation survey.
