**CLAY BED MODELING
ELIOT QUARRY- CEMEX AGGREGATES
ALAMEDA COUNTY, CALIFORNIA**

PREPARED BY: JEFF LIGHT, GEOLOGIST
P.G. #7661
JEFF LIGHT GEOLOGIC CONSULTING
15217 DE LA PENNA CIRCLE
RANCHO MURIETA, CA. 95683

DATE: DECEMBER 3, 2018

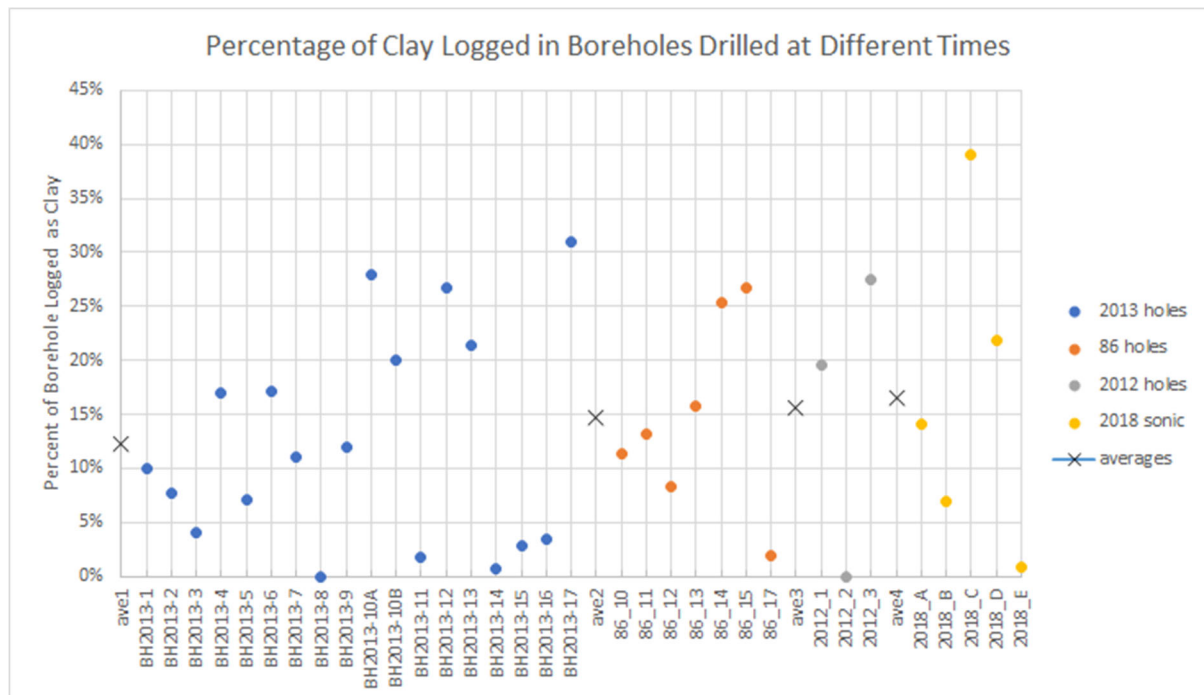
Figure 1. Comparison of the feet of clay logged divided by the total drill depth for the 2013, 86, 2012 and 2018 data. There appears to be no bias in percentage of clay logged between the different drilling and logging methods.

1. All of the borings drilled at the site are comparable relative to the percentage of clay encountered while drilling, independent of the drilling or logging methods used (Figure 1). JLGC has used all of the available data in developing its interpretation and understanding of the subsurface. Conversely, Zone 7 does not include the 21 Becker Hammer drill holes (2013) in their dataset, all of which are valid data points.

Prior to entering data into the geologic model, and to attempt to better understand why Zone 7 chose not to use the 2013 Becker Hammer data in their preliminary interpretations, JLGC checked the 2013 and 2018 drill hole data for potential logging bias. There was no observed bias in the percentage of clay logged between the 2013 Becker Hammer holes and the 2018 sonic holes (Figure 1). As such, consistent with standard geologic practice, all available data is used.

1. All of the borings drilled at the site are comparable relative to the percentage of clay encountered while drilling, independent of the drilling or logging methods used (Figure 1). However, Zone 7 does not include 21 Becker Hammer drill holes in their dataset, all of which are in the study area.

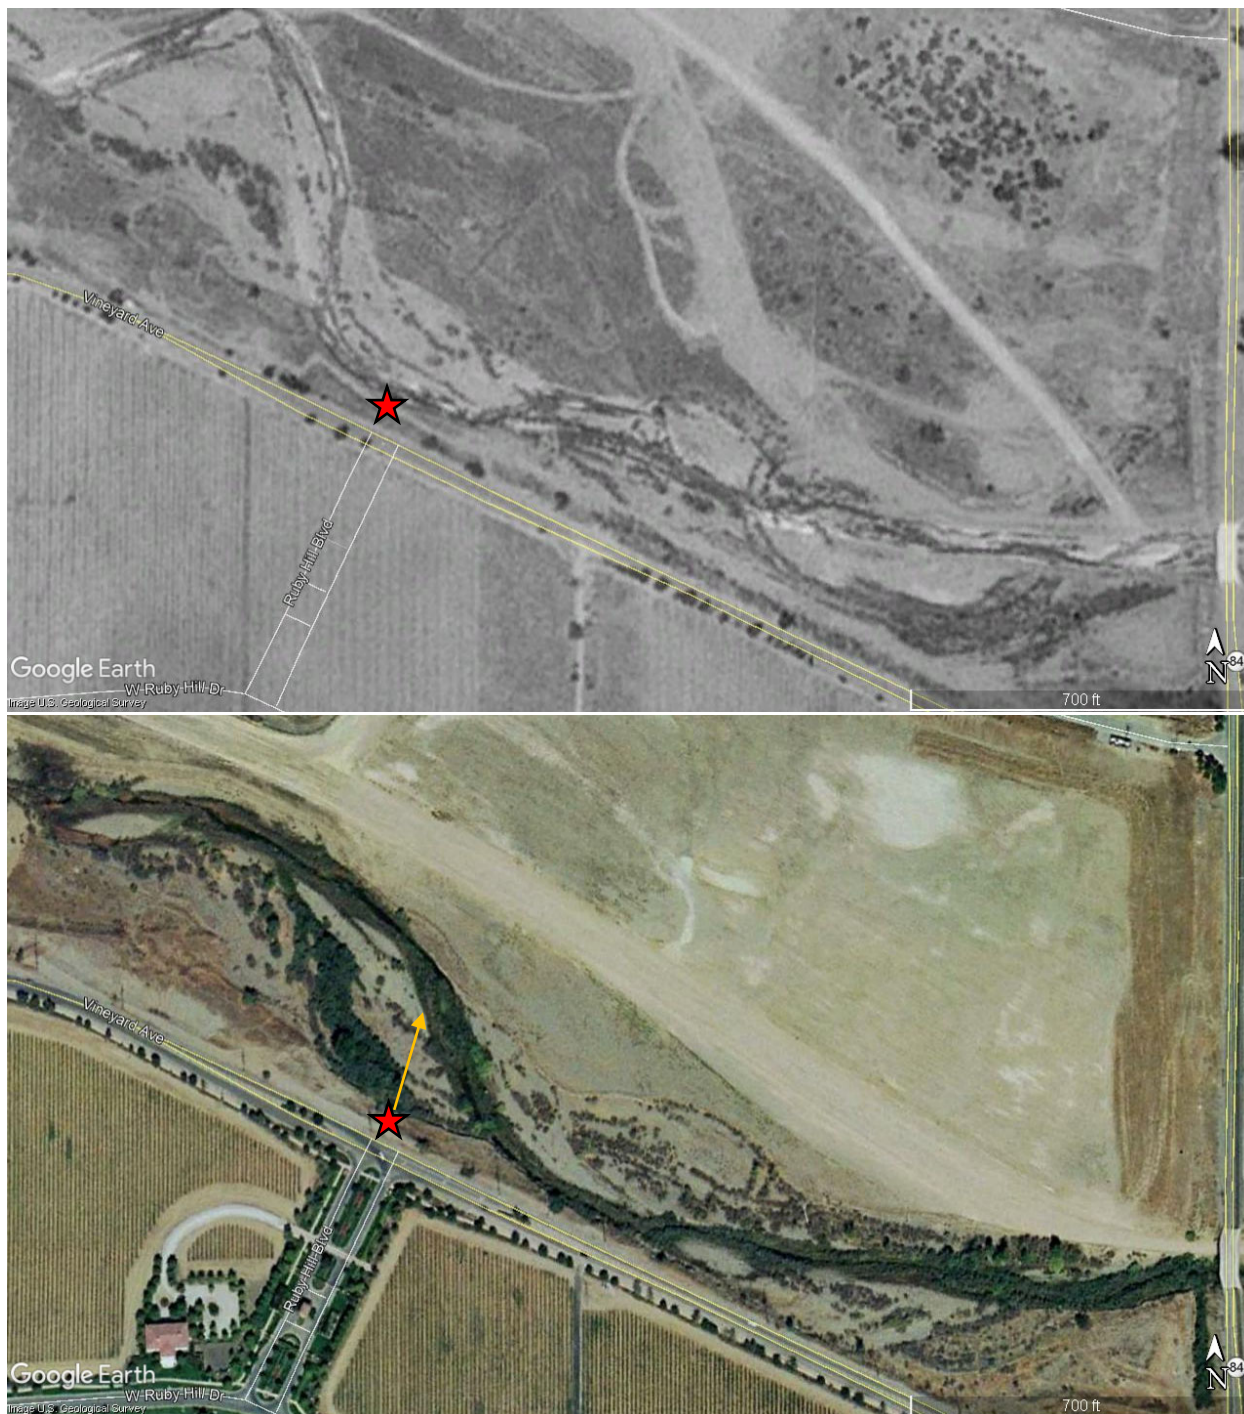
Figure 2. Google Earth aerial photos from 6/11/1993 and 10/30/2002 showing a multiple channel braided depositional system. The photo shows the area over the eastern portion of Lake B. Isabel Rd runs north-south along the right side of the photos. Over a ten year period the channel that was up against Vineyard Ave and the north point of Ruby Mill Blvd had been abandoned and the main channel was no 225' to the northeast.

3. Zone 7 interprets that Clay 6 should crop out in the walls of Lake B. There are no clay beds observed in the walls of Lake B.
4. The sand and gravel being mined at the CEMEX Eliot facility was deposited in a braided stream environment (see Figure 2). Generally, braided streams do not provide for continuous bank-to-bank clay beds that form aquitards.

Figure 2 shows that the Arroyo del Valle is a braided stream depositional environment. Braided streams are characterized by high sediment loads, with proximal highlands and relatively steep stream gradients. The channel system consists of several anastomosing channels that jump and migrate frequently due to the high sediment load (Figure 3). These can result in abandoned channels that can be later filled by a future depositional event. Outside of the channel system is an off-channel flood plain. Sands and gravels are prevalent in the channel system and fine-grained silts and clays are restricted to floodplain deposits and abandoned channel fills. Channel deposits consist of coarse materials deposited in point bars and bed loads. Floodplain deposits consist of fining upward beds of silt and clay. A fining upward sequence represents a single depositional event where the coarser materials (such as gravels) are deposited earlier in the event and finer materials (such as clays) are deposited as the flood flow velocity begins to decrease over time. Channel fills are old abandoned channels that are low spots and collect fines during flood events and stagnant water periods. Examples of geophysical logs (gamma response) and depositional environment correlations are provided in Figures 4 and 5. Gamma response patterns give clues to the distribution of clay in the deposit and depositional environments can be inferred from those patterns.

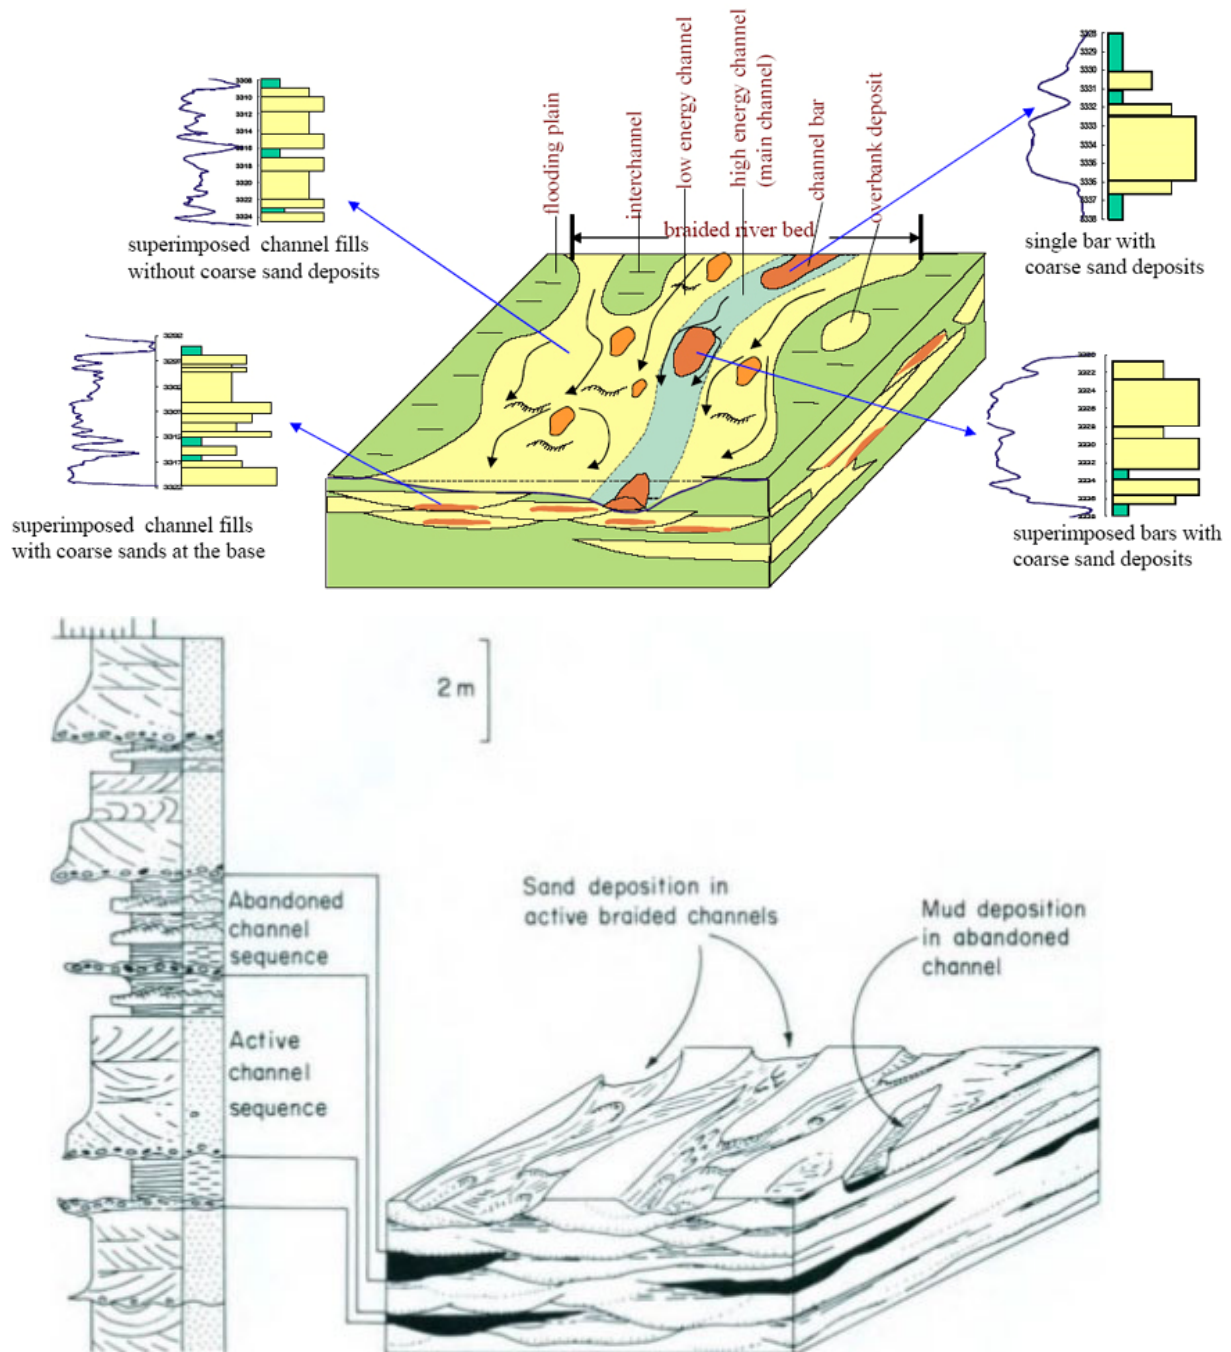
Physiography and deposits of a braided alluvial channel system. Sedimentation occurs almost entirely in the rapidly shifting complex of channels. Silts are rarely deposited in abandoned channels. A floodplain is absent.

Figure 3. Block diagrams of braided alluvial channel systems. Both diagrams show the discontinuous nature of fine-grained materials in this type of depositional system. Clay beds are spotty and eroded by frequently migrating channels resulting in discontinuous and unconnected clay beds. Source: *Principles of Sedimentology and Stratigraphy* (4th Ed.), Sam Boggs.

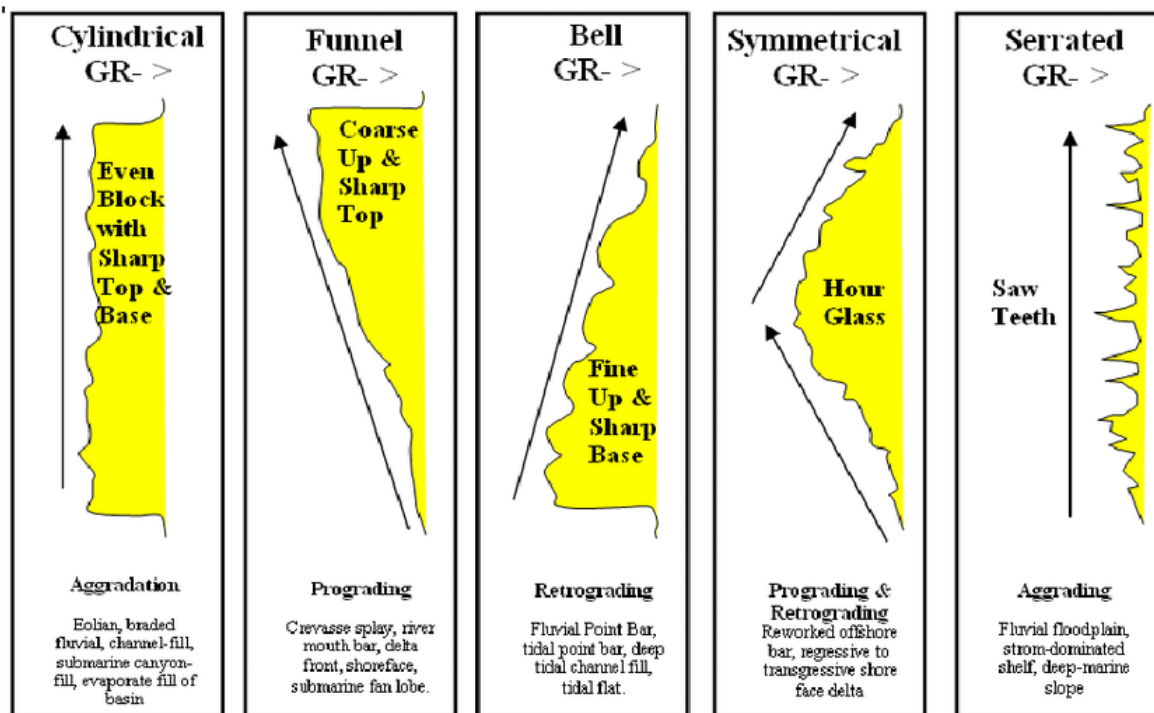
Figure 4. Diagrams showing the gamma ray response to changes in deposit grain-size and clay content. Gamma ray geophysical tools measure the natural radiation given off by decaying radioactive elements native to the geologic material being sampled. In deposits that contain clay (clay contains abundant Potassium) there is a natural increase in radioactivity with an increase in clay content. The pattern to the gamma response gives clues to the distribution of clay in the deposit and depositional environments can be inferred from that pattern. Source: *Principles of Sedimentology and Stratigraphy* (4th Ed.), Sam Boggs.

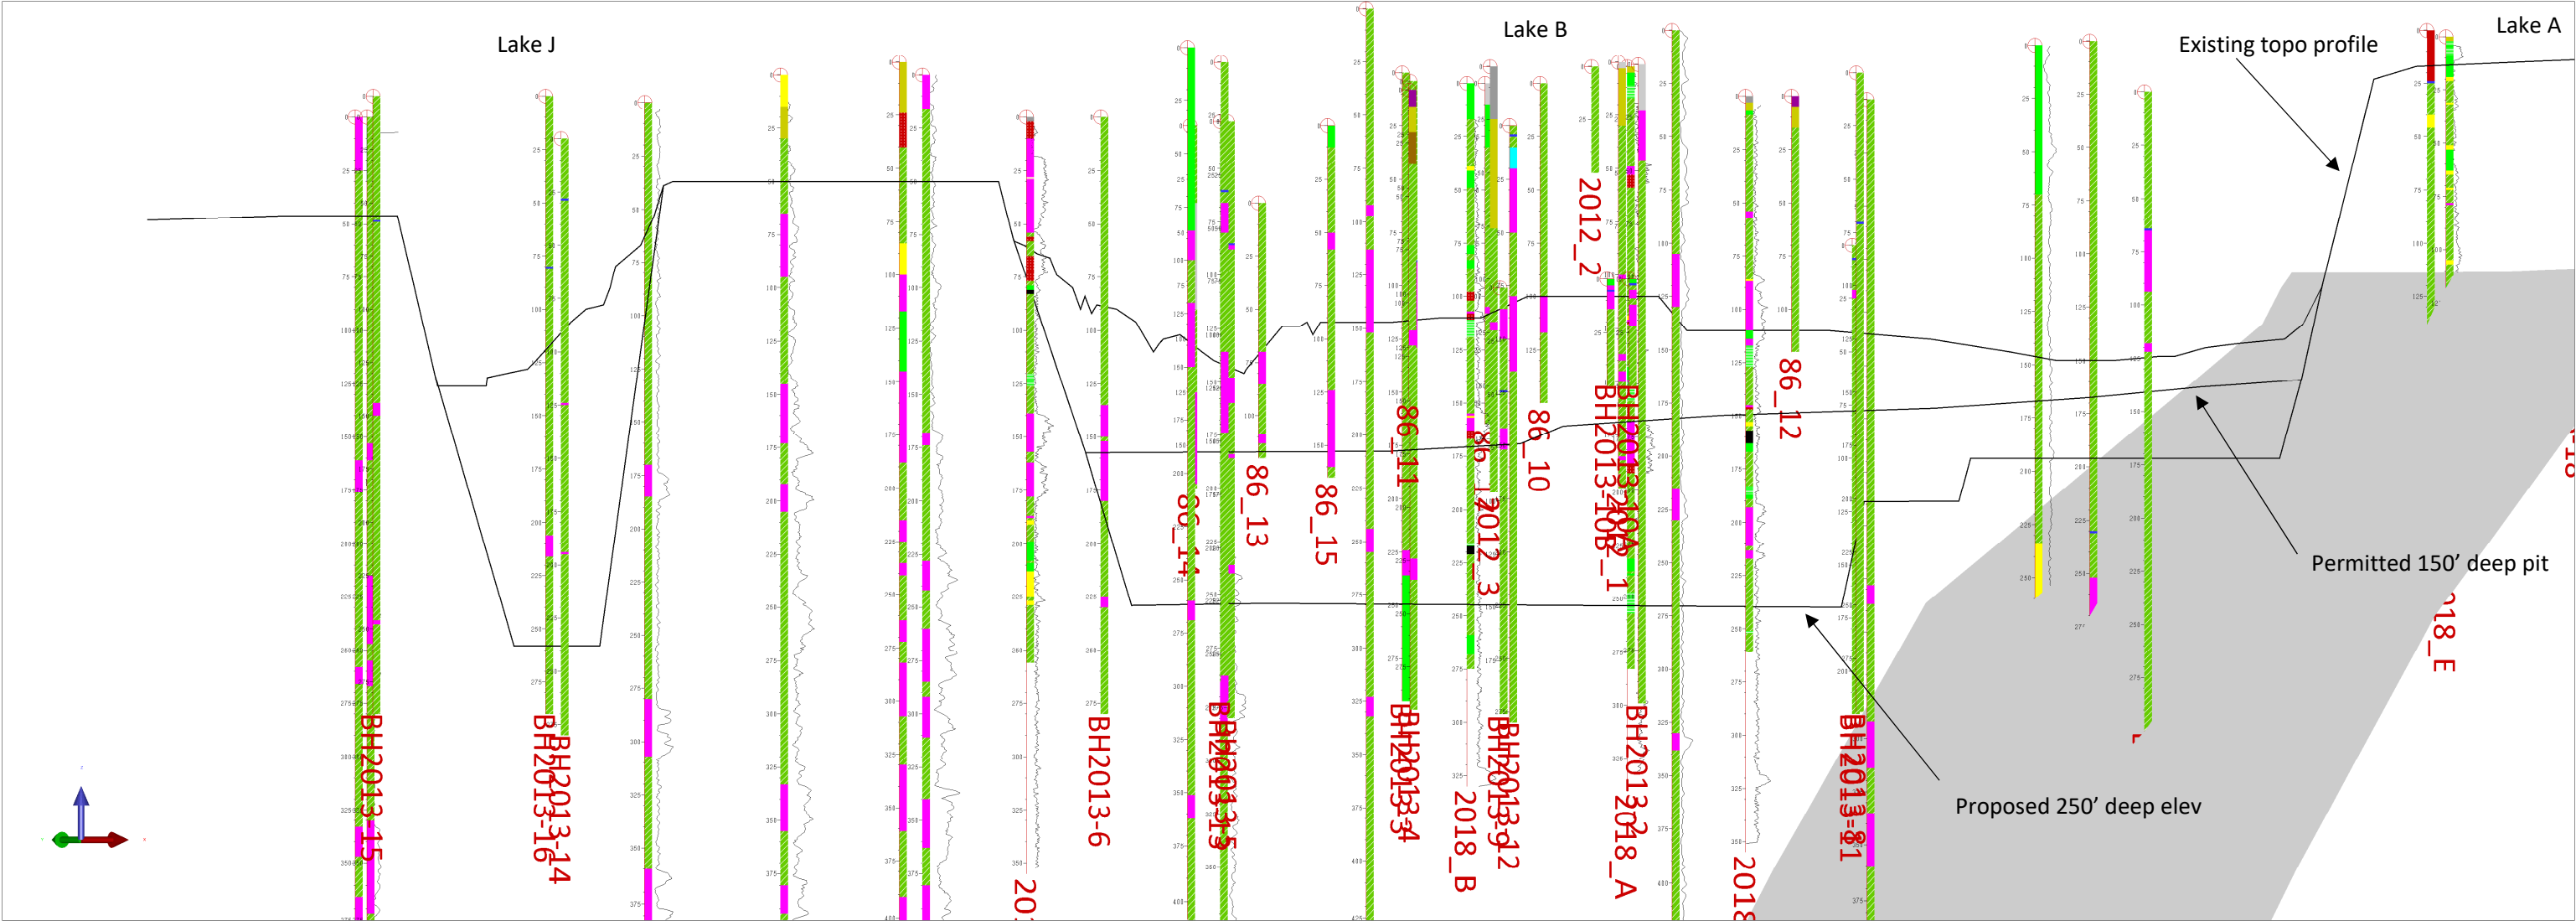
Figure 10.
Erosional Unconformity Location Map
(blow up)
10x vertical exaggeration

This is a two-dimensional depiction of a three-dimensional model. The “Older Geologic Deposits” do not intersect Lake B, but run behind Lake B to the northeast.

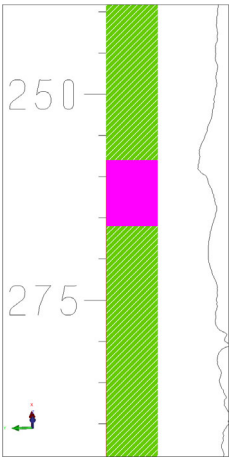
Gamma Signature
Clay 7- Hole 3S-1E-14A3
Curve looks like resistivity
data, not gamma data

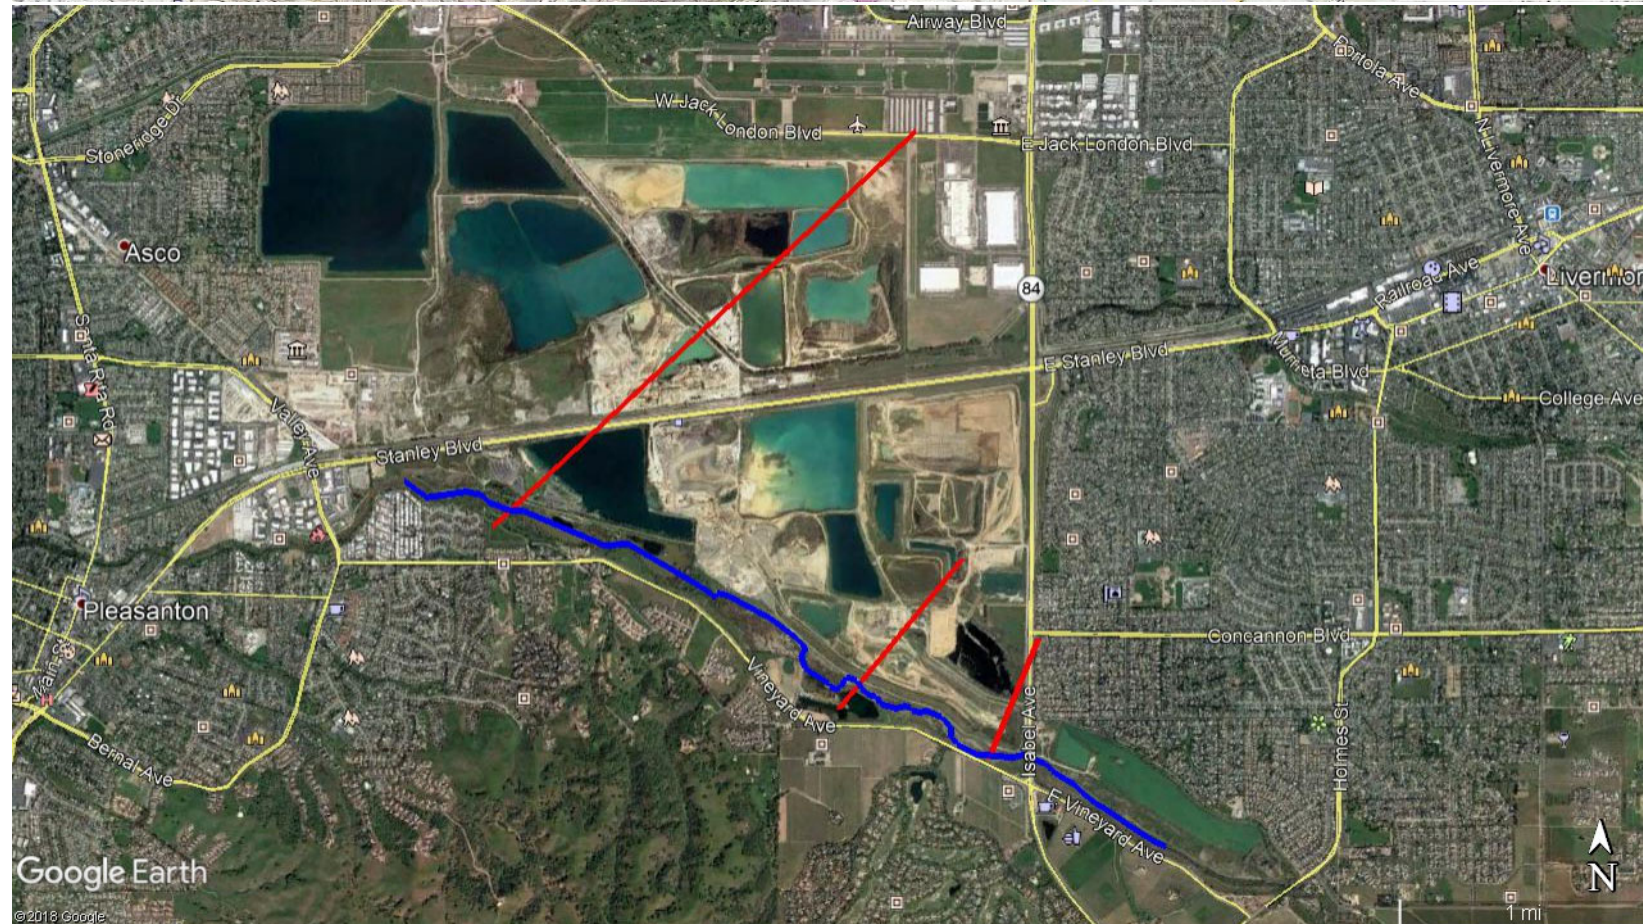
GOOGLE Earth aerial photo 4/22/2018

Red lines show lines of equal topo elevation across the Arroyo del Valle floodplain

Floodplain topographic gradient is
 $\sim 0.2\%-1\%$ grade (red lines) $\sim 300^\circ$ dip
 direction and the Arroyo del Valle stream
 gradient is $\sim 0.6\%$ grade (blue line) $\sim 290^\circ$
