APPENDIX E-2 GEOTECHNICAL INVESTIGATION/SLOPE STABILITY REPORT FOR ADV

GEOTECHNICAL INVESTIGATION / SLOPE STABILITY ANALYSIS Subject:

CEMEX ELIOT - ARROYO DEL VALLE REALIGNMENT AT LAKE B

ALAMEDA COUNTY, CALIFORNIA

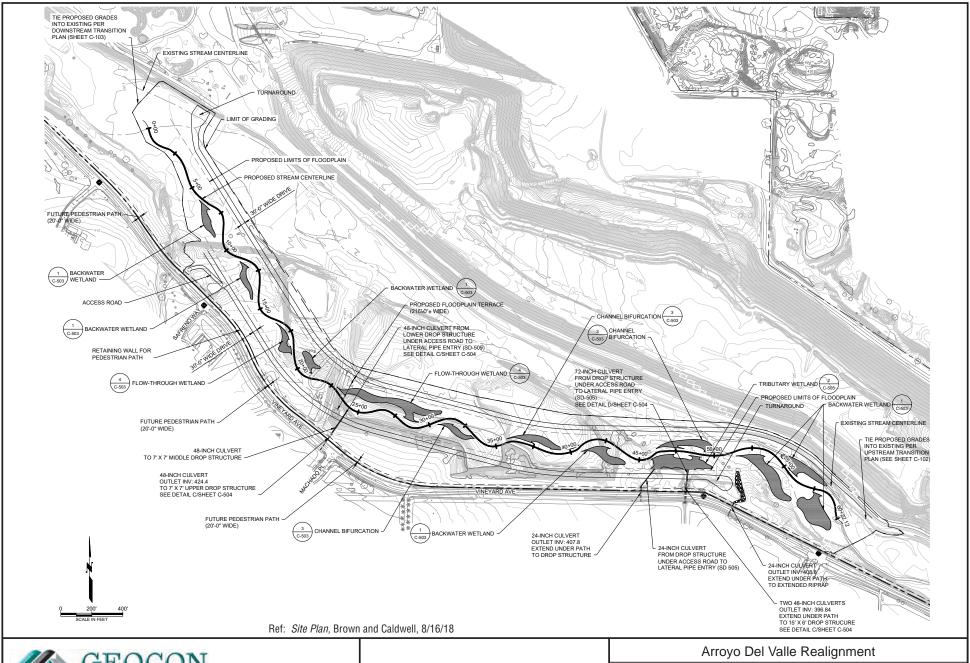
PROPOSED PROJECT OVERVIEW

Arroyo Del Valle Realignment				
Cemex Eliot Mine Alameda County, California				
S1264-05-01 December 2019 Figure 2

CEMEX Construction Materials Pacific, LLC (CEMEX) owns and operates the Eliot Facility, a sand and gravel mining operation located between the cities of Pleasanton and Livermore within the unincorporated area of Alameda County, California (Vicinity Map, Figure 1). CEMEX is seeking approval to amend its existing *Reclamation Plan*, which was originally approved in 1987 under *Surface Mining Permit 23* (SMP-23). In December 2016, an updated application for SMP-23 was submitted to the Alameda County Community Development Agency. The *Amendment* presents options for mining Lake B to an elevation of 150 feet above mean sea level (MSL), which is approximately 100 feet deeper than the currently mined elevation. Under the preferred option outlined in the *Amendment*, CEMEX proposes to move ADV south along a new alignment parallel to Vineyard Avenue to allow for the southerly progression of mining at Lake B. As part of the project, the ADV corridor in this area will be restored and enhanced by creating aquatic habitat and native plant species. An overview of the proposed project is presented as Figure 2.

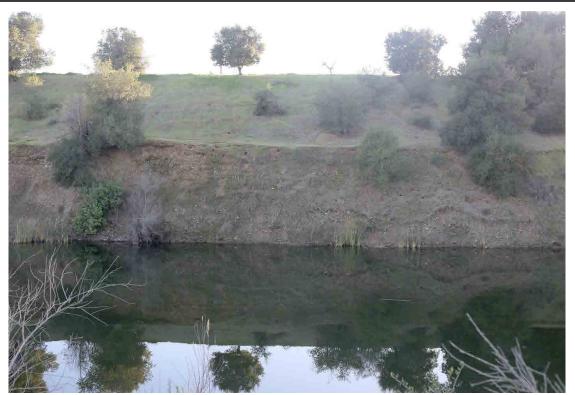
Photo No. 1 Embankment of Quaternary alluvium on the south side of the South Topcon Pond (December 2016)

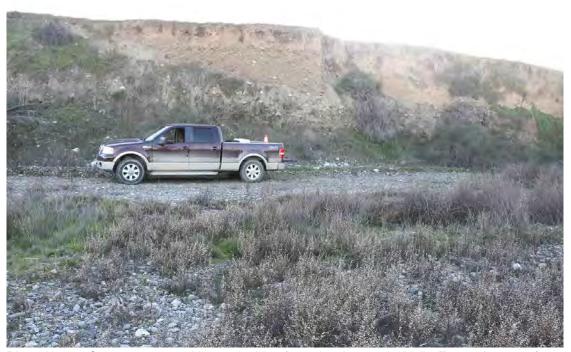
Photo No. 2 Quaternary gravel in south side of existing Arroyo del Valle (December 2016)

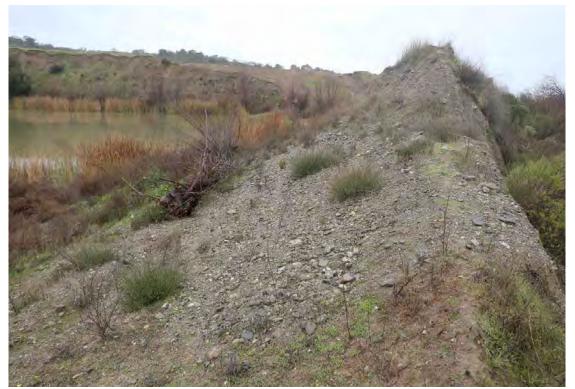
Photo No. 3 Ridge of Quaternary gravel between the Pond west of the Topcon facility and Arroyo del Valle (December 2016)

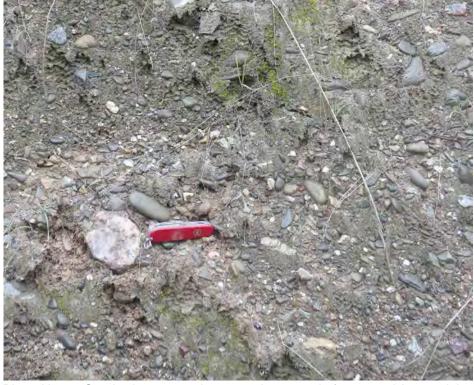
Photo No. 4 Sandy clayey gravel near northwest end of proposed Arroyo del Valle realignment (January 2017)

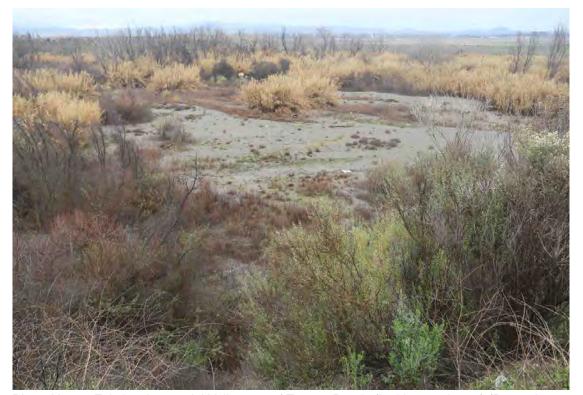
Photo No. 5 Existing Arroyo del Valle west of Topcon Ponds (looking northeast) (December 2016)

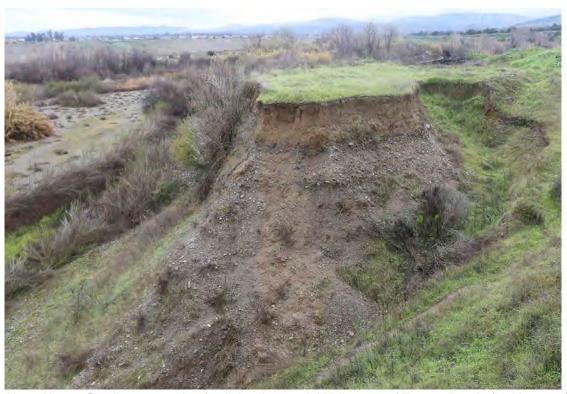
Photo No. 6 Southwest margin of existing Arroyo del Valle west of Topcon Ponds (looking east) (December 2016)

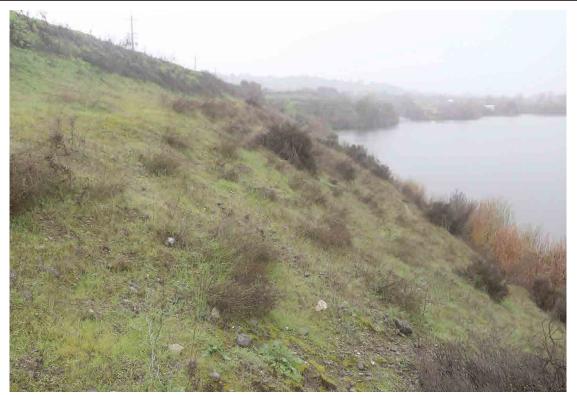
Photo No. 7 South embankment above the Northeast Topcon Pond (December 2016)

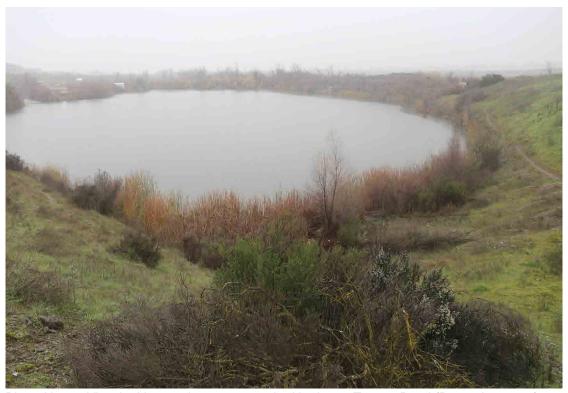
Photo No. 8 View looking northwest across the Northeast Topcon Pond (December 2016)

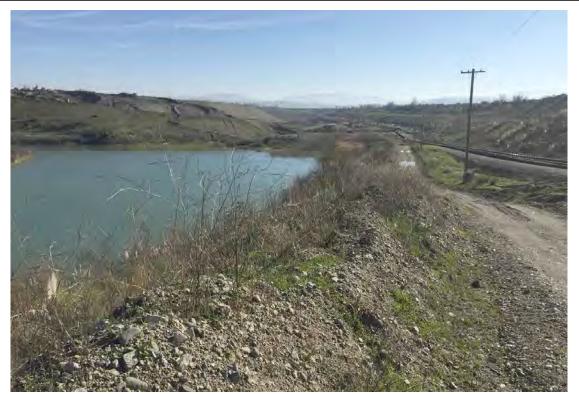
Photo No. 9 Looking southeast at Lake B. Borrow Area #1 (Clay) at far end of the lake (December 2016)

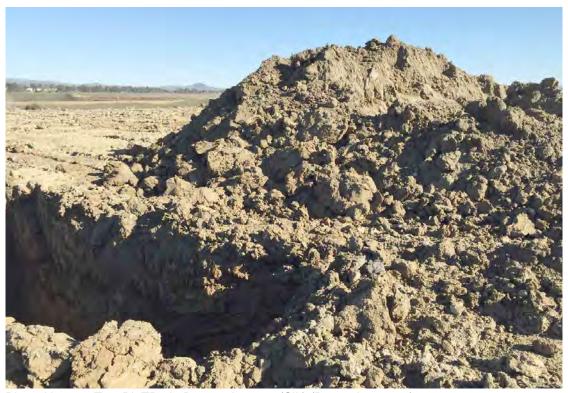
Photo No. 10 Test Pit TP2 in Borrow Area #2 (Silt) (December 2016)

We encountered fill within TP1 through TP3 performed within Borrow Area #2 containing "silt" deposits resulting from onsite aggregate processing (Photos 10 and 11). Based on our test pits, the fill generally consists of a heterogeneous mixture of sandy lean clay (CL) with gravel and some small cobble (Photo 10). Gravel and small cobble is typically rounded and consists of maximum particle

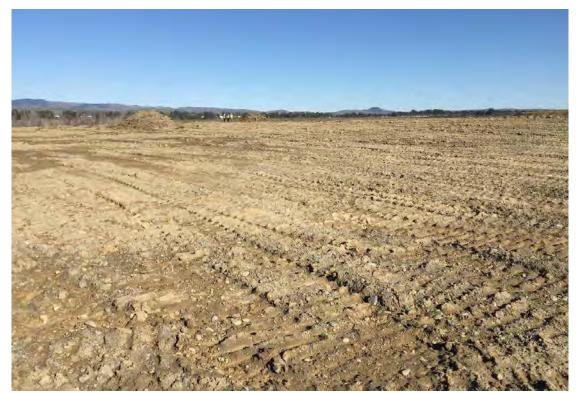
Photo No. 11 Borrow Area #2 (Silt) with soil piles excavated from TP2 (left) and TP3 (right) (December 2016)

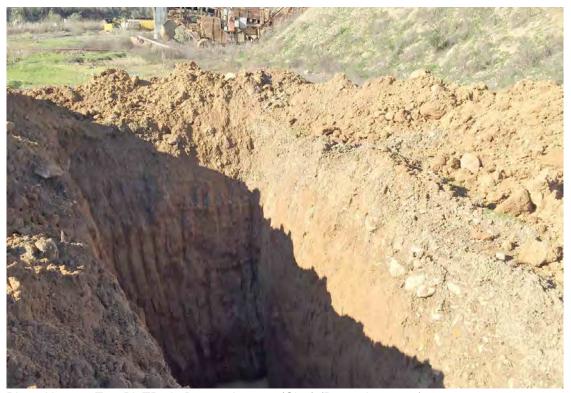
Photo No. 12 Test Pit TP4 in Borrow Area #1 (Clay) (December 2016)

<u>Clay Deposits</u>: These deposits generally consist of sandy lean clay (CL) with little gravel (Photo 12). Gravel within the clay is typically subrounded to rounded and generally 1½ inches or smaller in maximum dimension. This material exhibits low to moderate plasticity and stiff to very stiff consistency.

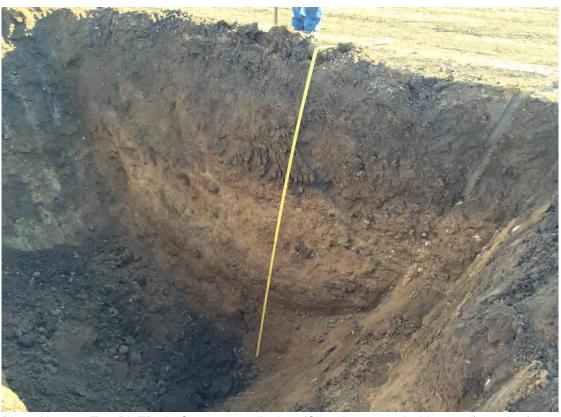
Photo No. 13 Test Pit TP8 in Quaternary alluvium (Silty clayey sand with gravel) south of the South Topcon Pond (December 2016)

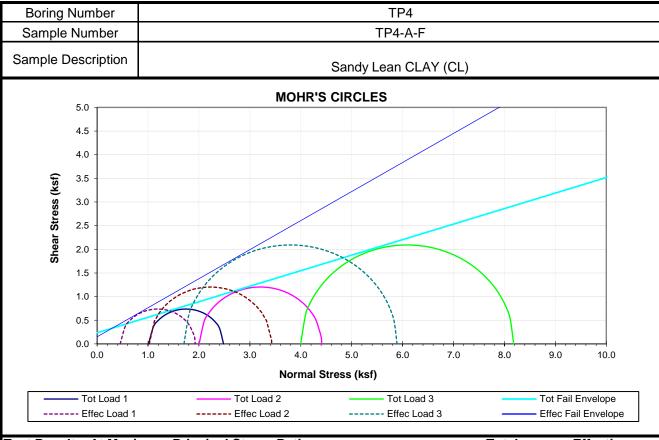
Consolidated Undrained Triaxial Compression - ICU Test ASTM D4767

Test Results, At Maximum Principal Stress Ratio	Total	Effe	ective
Friction Angle φ (degrees)	18.2	31	.6
cohesion (psf)	235	15	0
Initial Conditions at Start of Test	stage 1	stage 2 stag	e 3
Sample ID (psf), Initial Confining Pressure	1000	2000 40	00
Height (inch)	5.010	4.978 4.8	95
Diameter (inch)	2.414	2.446 2.4	48
Moisture Content (%)	11.3		-
Dry Density (pcf)	114.4		5
Saturation (%)	64.6		-
After Saturation			
Dry Density (pcf)	111.9		-
After Consolidation			
Dry Density (pcf)	112.1		5
Shear Test Conditions			
Dry Density (pcf)	112.1	113.7 115	5.5
Moisture Content (%)		16	.7
Saturation (%)		98	.3
Strain rate (%/hr)	1.86	1.89 1.9	95
Cell pressure (psf)	11220	12210 142	30
Initial Back Pressure (psf)	10210	10210 102	:30
Initial Effective Confining Pressure (psf)	1010	2000 400	00
Total Major Principal Stress At Failure (psf)	2480	4410 818	80
Effective Major Principal Stress At Failure (psf)	1930	3430 589	90
Pore Pressure At Failure (psf)	560	980 229	90

Effective Minor Principal Stress At Failure (psf)	450	1020 17	10

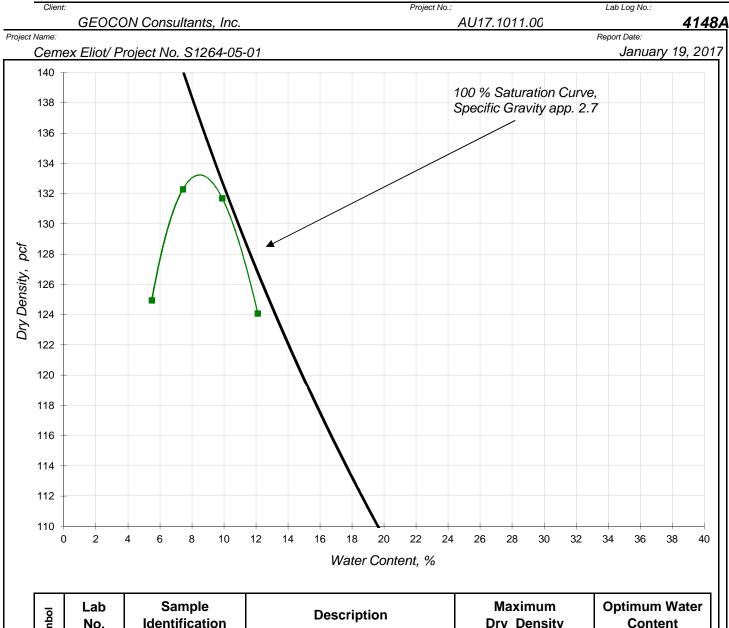
Test Report ASTM D - 1557

Symbol	Lab No.	Sample Identification	Description	Dry Density				Optimum Water Content
Ś				pcf	kg/m³	%		
•	4148A	TP 7/8 (3-12)	Brown Sandy Silty, Clay with Gravel	133.2	2134	8.5

Corrected Values For Oversized Particles, per ASTM D-4718

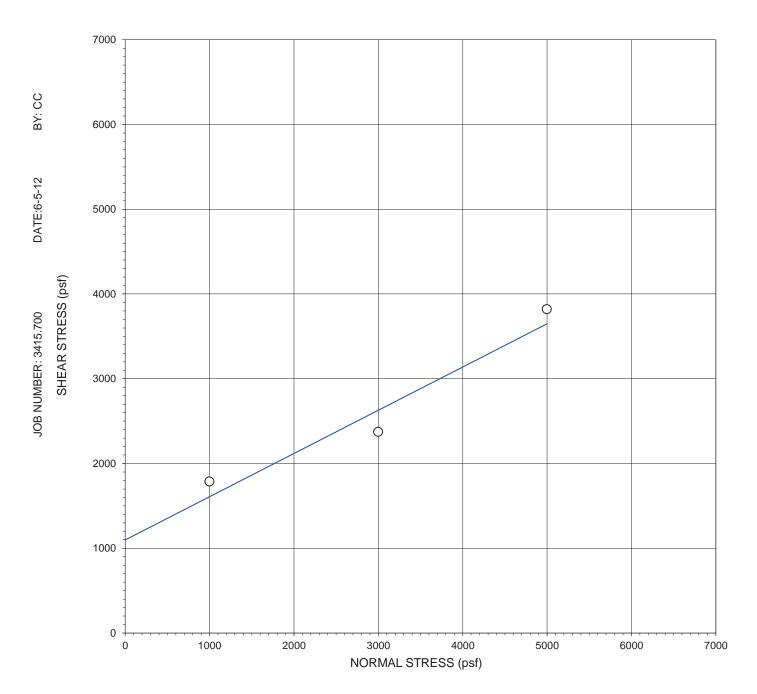
LOCATION: B-1 at 32 feet

SAMPLE: CLAYEY SAND with GRAVEL, brown

SPECIMEN	Α	В	С
DRY DENSITY (psf)	127.1	123.7	123.4
INITIAL WATER CONTENT (%)	10.1	10.1	10.1
FINAL WATER CONTENT (%)	11	13.7	11
NORMAL STRESS (psf)	1000	3000	5000
MAXIMUM SHEAR (psf)	1785	2373	3819

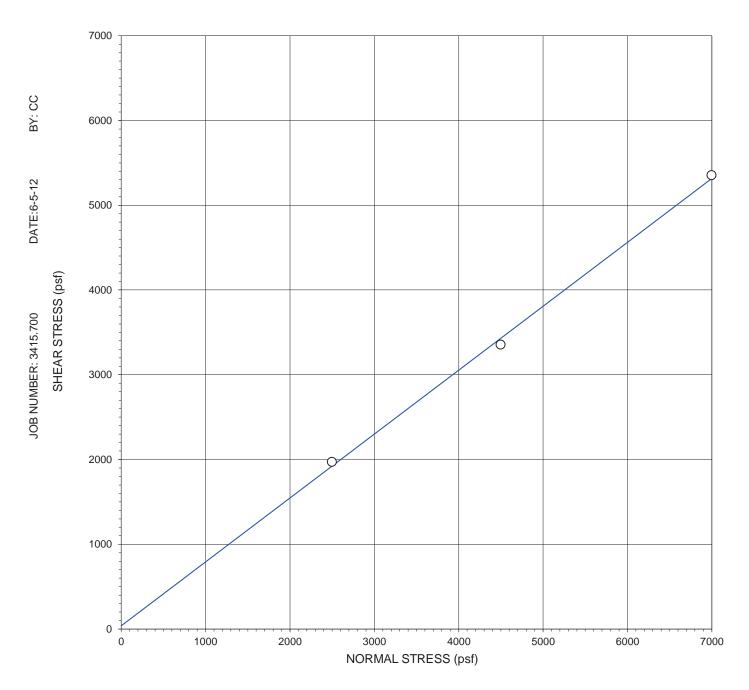
LOCATION: B-1 at 37 feet

SAMPLE: CLAYEY SAND with GRAVEL, red-brown

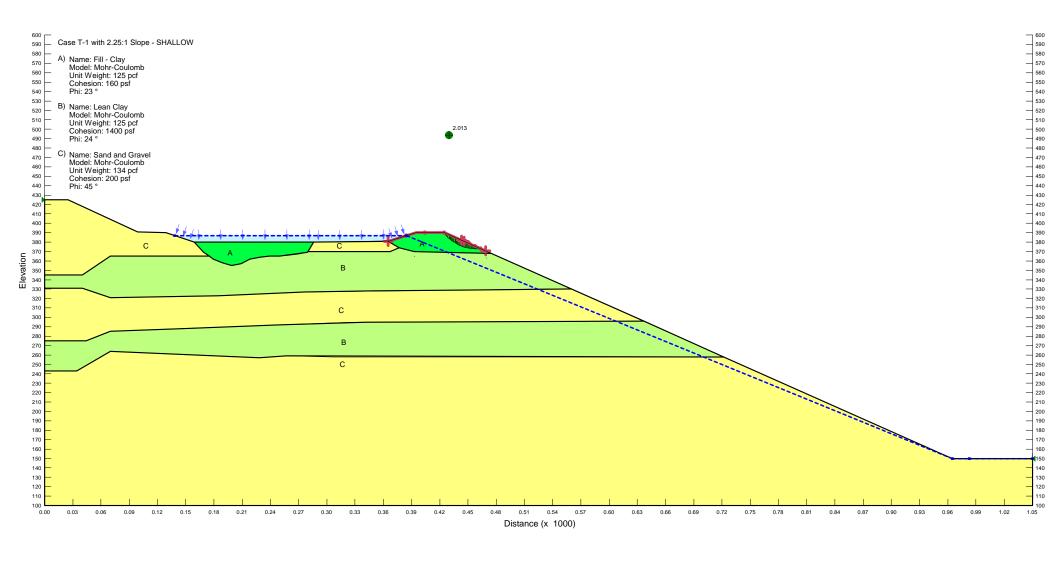
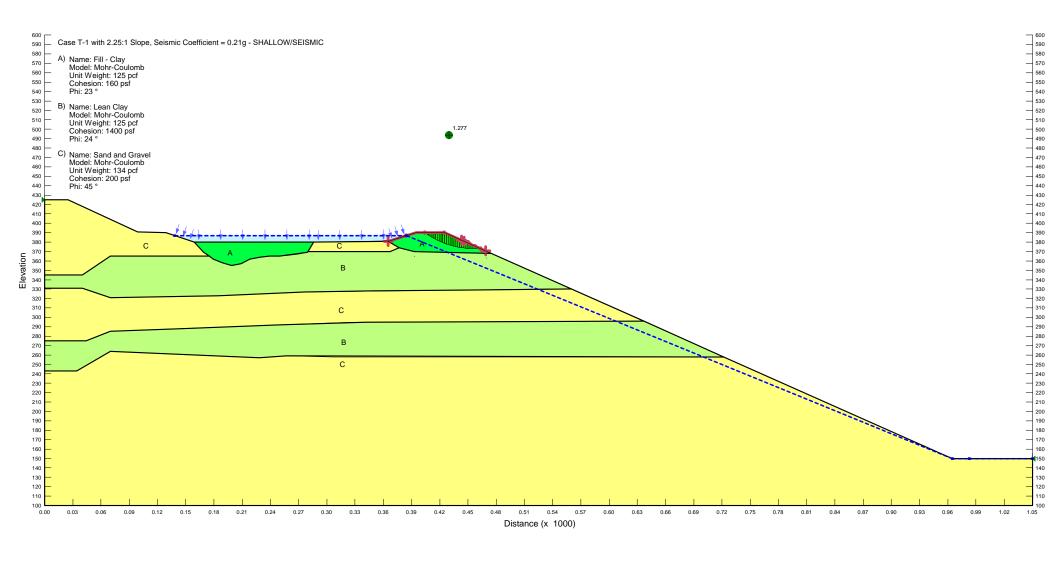
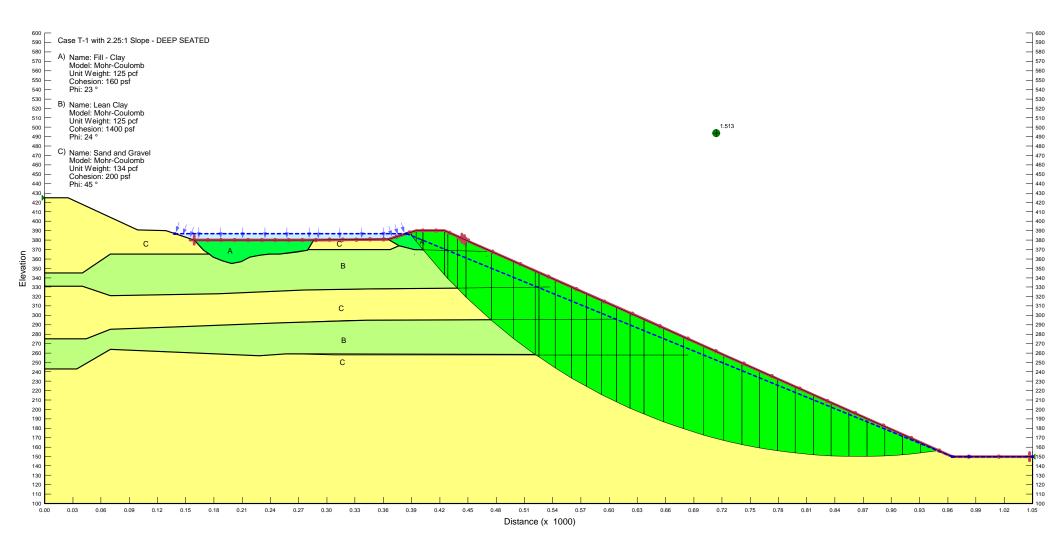
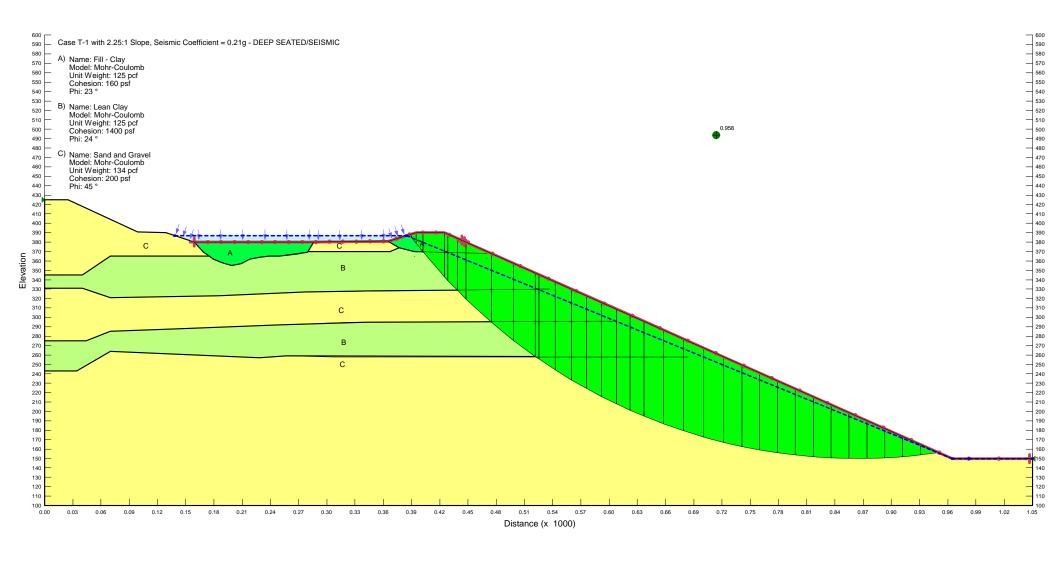
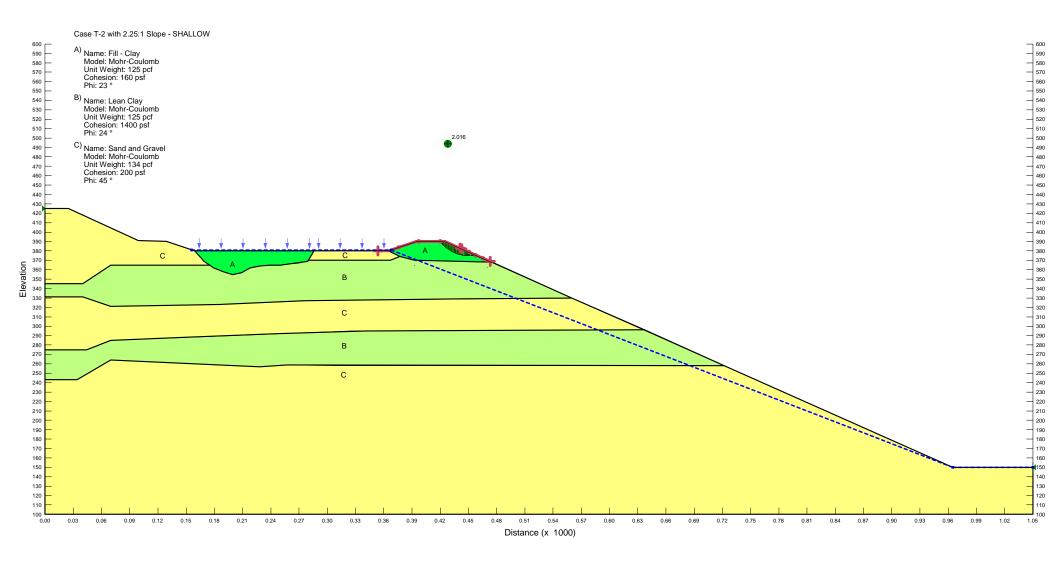
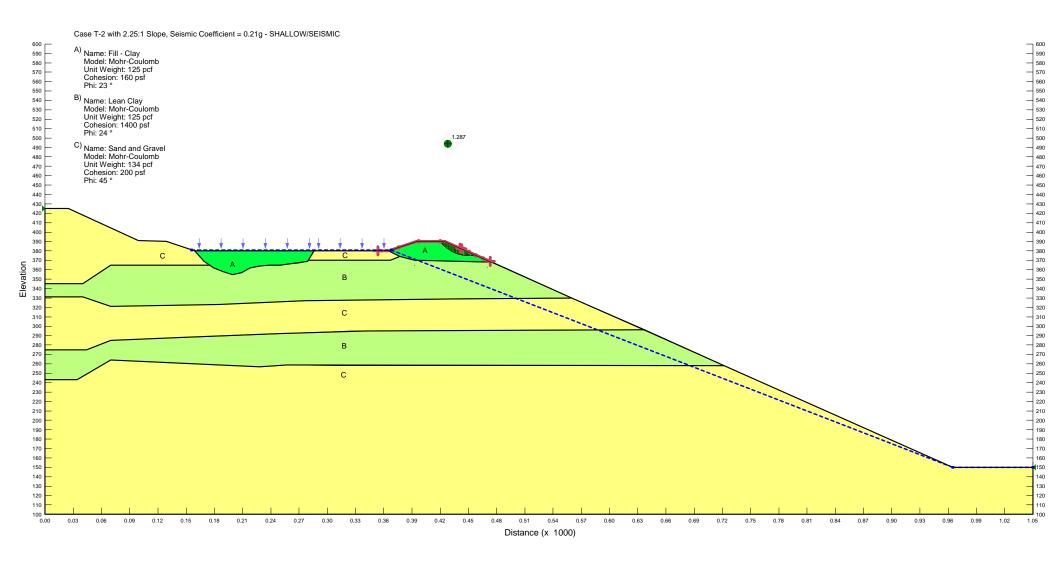
We used the computer program SLOPE/W Version 7.22 distributed by Geo-Slope International to perform slope stability analyses. SLOPE/W uses conventional slope stability equations and a two-dimensional limit-equilibrium method to calculate the factor of safety against failure. For our analyses, the Bishop's and/or Spencer's Method with a circular failure mechanism were used.

The computer program searches for the critical failure surface based on user-provided input parameters. For a circular failure search, a linear search of entry and exit locations is specified and the computer searches for the critical failure slip surface. Graphical representations of the slope stability analyses, potential critical failure surfaces, and parameters used for each analysis are presented on the following pages.
